A Second Wind

The idea of generating electricity using the wind appeals to many, but the reality is that wind systems demand the most planning, labor, and maintenance of any home-scale renewable electricity system. Homeowners and installers don't always get it right the first time, and there are lessons to be learned when they don't.

by Ian Woofenden

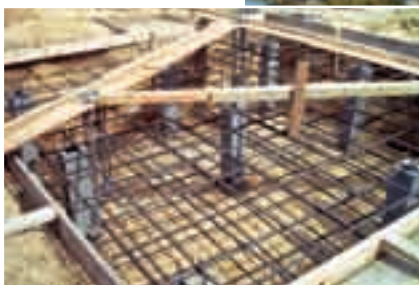
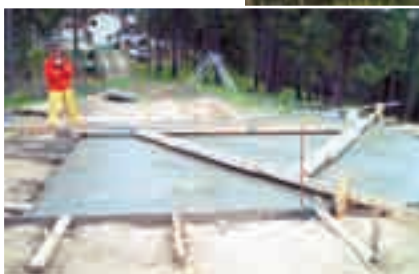
The tower and turbine at its original site in Chelan County, Washington.

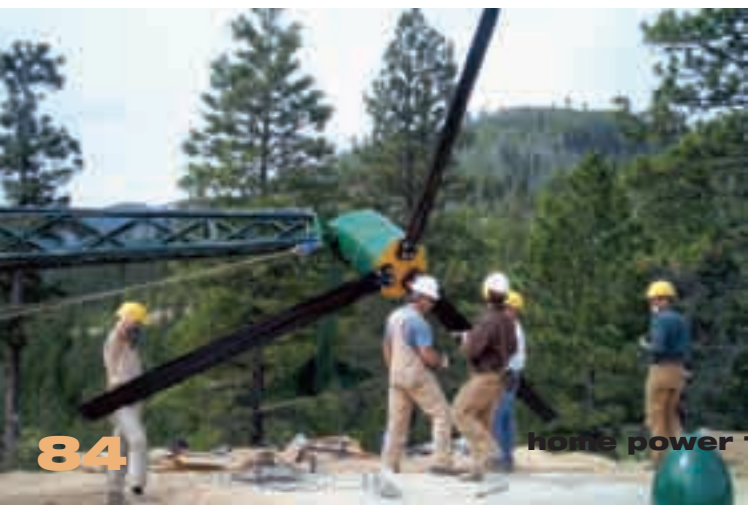
Inset, top: The forms, rebar, and rebar supports. Inset, bottom: The finished tower footing.

The wind installation moved from concept to project over the next few years, with the concrete footing poured in May 2002, and the 100-foot tower and Bergey Excel turbine installed in October 2002. Randy was joined by Bill Hoffer in prepping the site, and by his western Washington crew of Kelly Keilwitz, Rose Woofenden, and yours truly for the tower assembly and crane installation.

What happened? The owners' eagerness coupled with a lack of solid resource data led to a waste of time, effort, and 48 cubic yards of concrete in the ground, and about \$55,000 spent. While external appearances and anecdotal observation seemed to indicate a good wind site, the reality of low wind speeds and poor turbine production proved otherwise.

After almost four years, Don and Bev concluded that they had made a poor investment, and advertised the machine and tower for sale. The concrete weighs more than 70 tons, so reusing it in another location was out of the question, but Don and Bev hope to use it as a level surface for a future PV array.

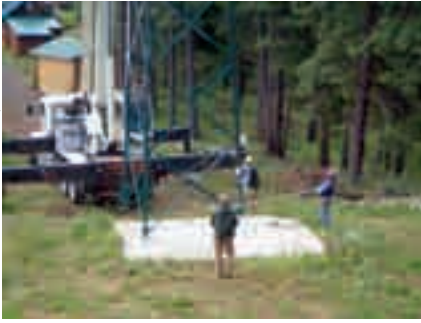
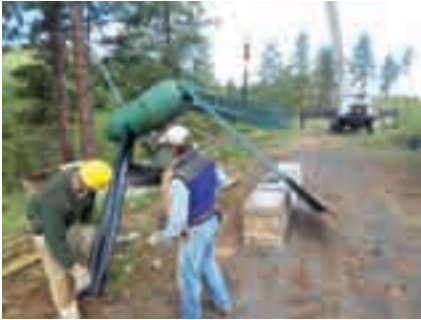
The turbine was assembled on the tower, then lifted onto the base by a crane.

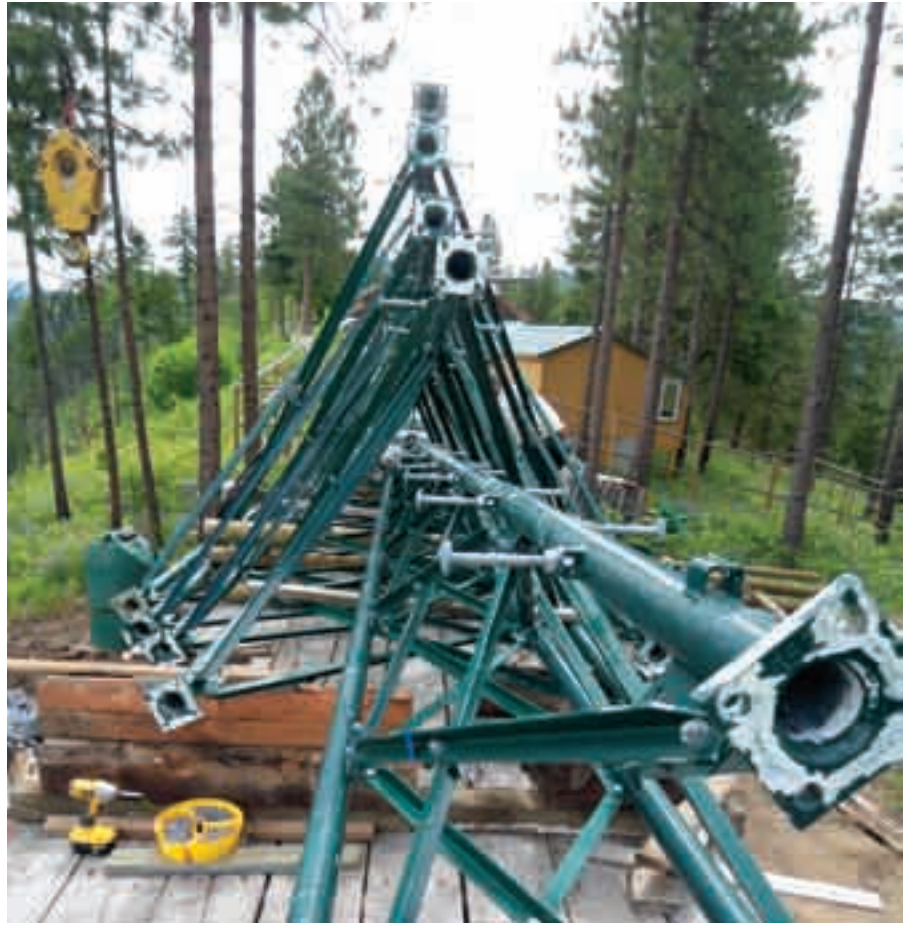
Once it was confirmed that a lack of wind was the culprit causing low energy output, the system was disassembled and loaded onto a flatbed trailer for transport to a new site.

While Randy Richmond worked with local authorities for permission to site the turbine on his vacation property, Randy Brooks gathered his de-installation crew. In early June, we attached a crane, unbolted the tower from the foundation, and tipped the whole thing over. Turbine blades, tail, and then generator were removed and stowed, leaving us with a bare tower.

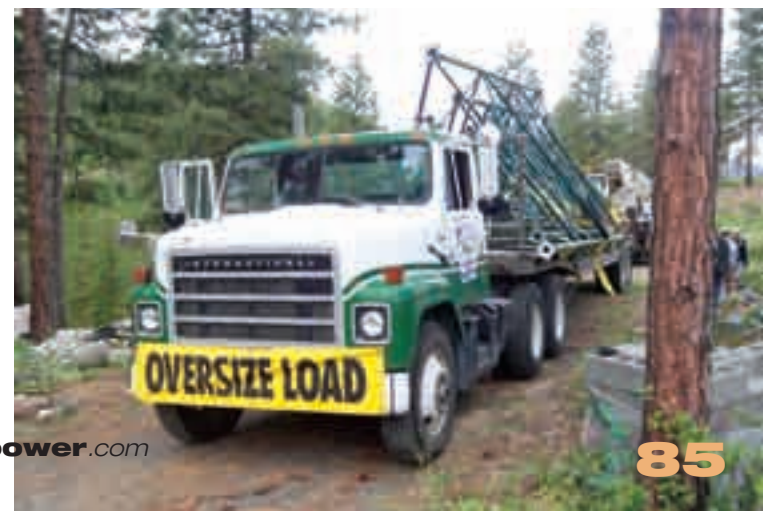
The truck, with tower and turbine ready for transport.

Brooks had arranged for a flatbed semi trailer to haul the tower and

turbine 40 miles to Ellensburg. We decided to partially disassemble the tower into five 20-foot sections. This strategy worked well, and we nested the sections on the semi, with the turbine strapped down on the back end. All then headed south, leaving a bare concrete slab at the Grim property.

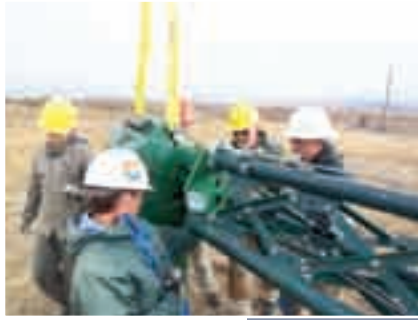
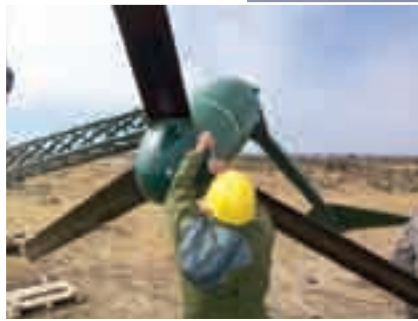
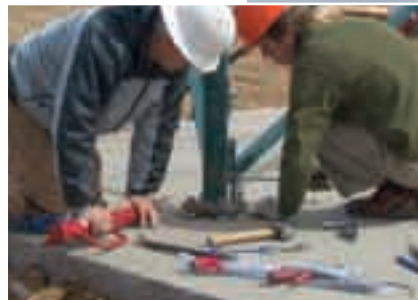
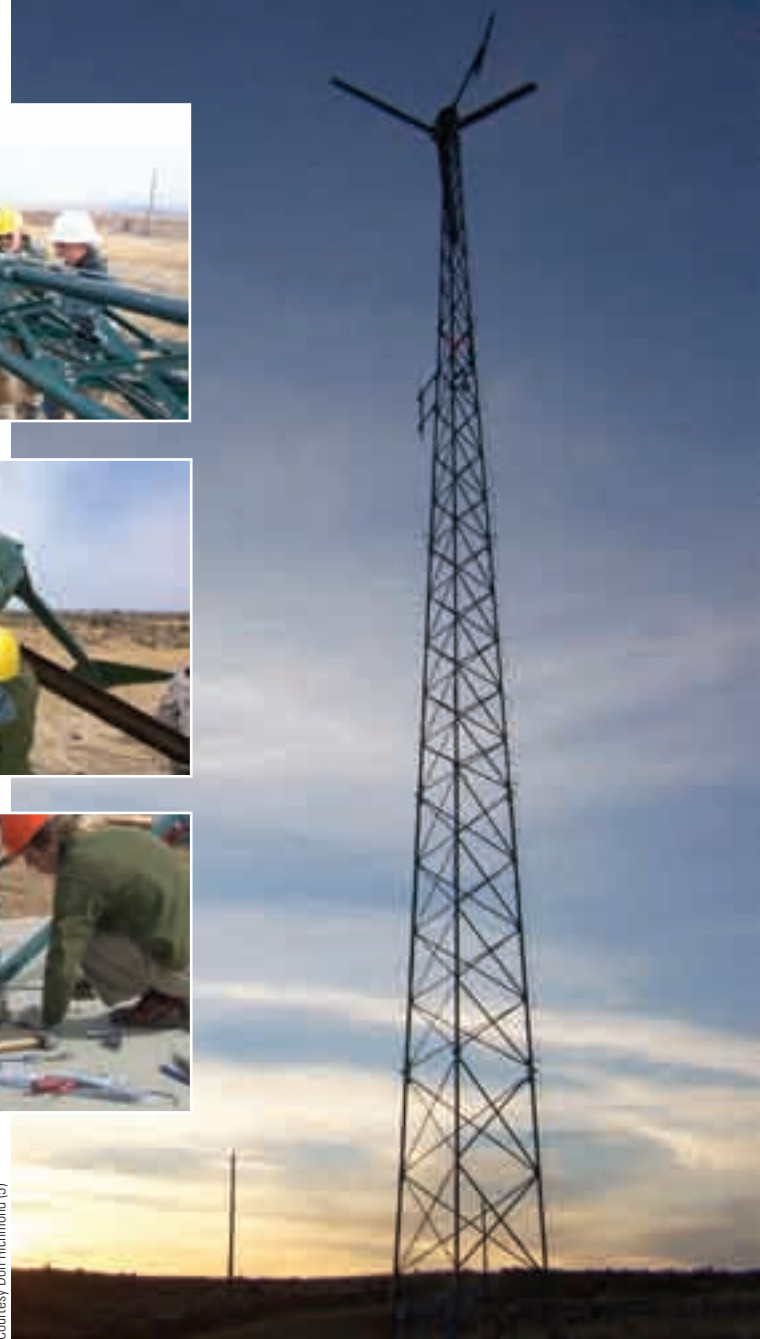
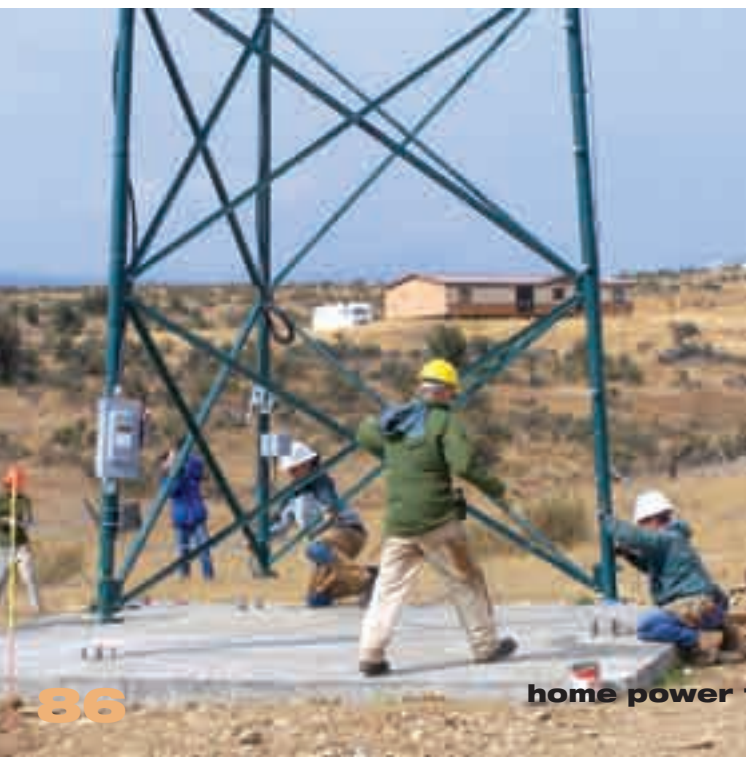
The turbine and tower are reassembled and hoisted at the new site—one with a considerably better wind resource.

The crane lifted the tower so we could prop it up for room to install the turbine. We then lifted the turbine head and bolted it to the tower, followed by the tail and new, next-generation blades. The blade upgrade led to some head-scratching over the installation hardware and a field modification to make the nose cone fit properly. Meanwhile, with transmission wires secured, furling cable attached, and damper completed, we were ready to lift.

Once the tower and turbine were up, we ran ground wires to the ground rods, and performed electrical and furling tests on the turbine. We left the turbine running unloaded, an acceptable condition for this particular model.

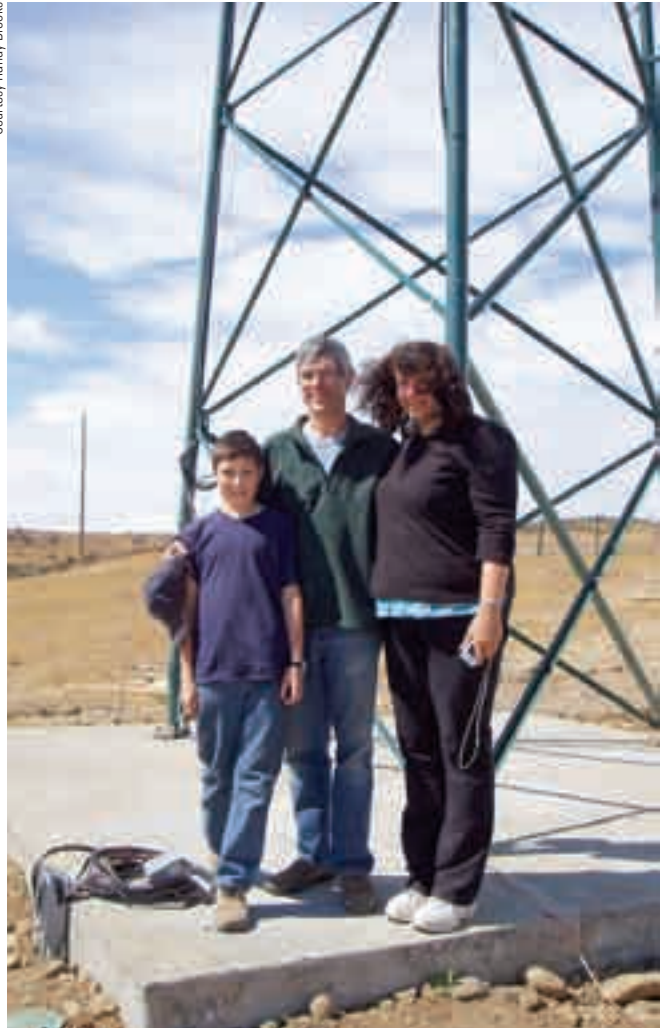
The turbine and tower, at their new home on the range.

Once final electrical approval was received from state authorities and the utility in October 2008, the system began to produce electricity. In its first 86 days of operation, the
